Date: 03/05/07
From: KMBS Logistics
Subject: Image Units Squeaking
bizhub C252: 010

Squeaking noise from IU

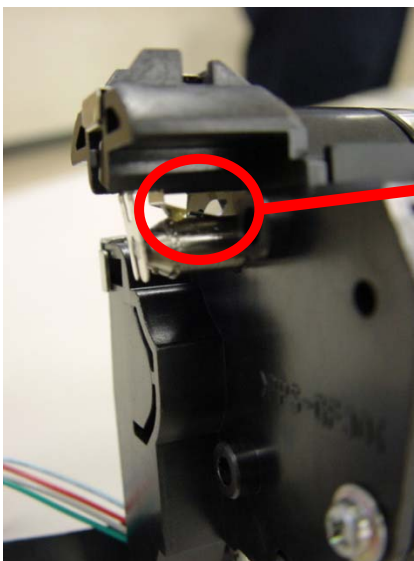
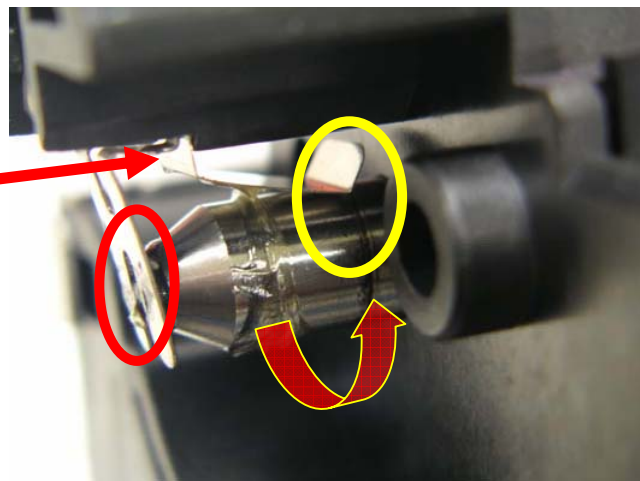
Squeaking noise coming from image unit shortly after installation.

Insufficient lubrication of the drum shaft

3. There are two contacts on the PC drum shaft. The squeaking noise comes from the yellow circle part (see below photo right), where no greases applied. Therefore take the grease from where there is grease on the PC drum shaft, and apply to the contact (yellow circle part) with tweezers or small screw driver.

Apply the conductive grease to the contact on the shaft. Be sure to read the attached instructions.
